MICROSCOPIC EVALUATION OF A POLYIMIDE (PMR15)-GRAPHITE COMPOSITE

Jeffrey J. Fedderly and Joseph M. Augl
Naval Surface Weapons Center

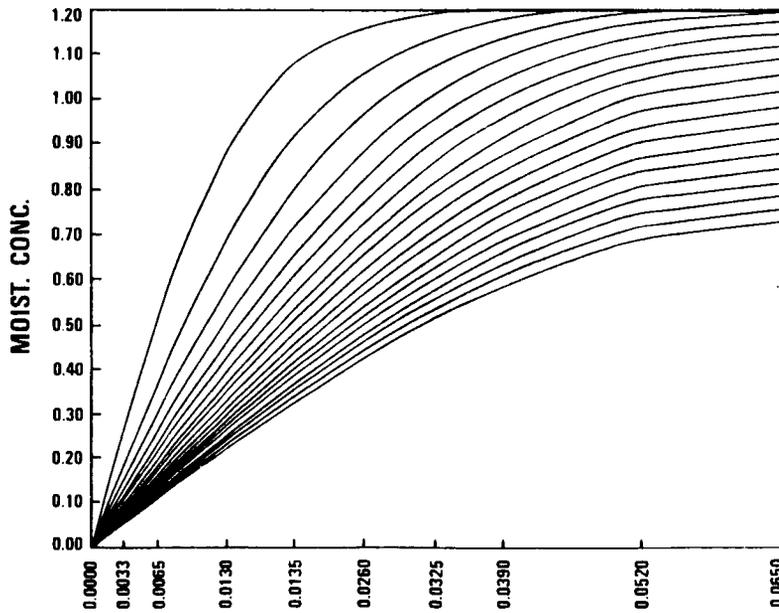
Both 4 and 8 ply specimens which had been equilibrated to an 80% R.H. environment were thermally cycled between room temperature and 473°F as described in the experimental section. The 8 ply material was subjected to 50 cycles of 4 minutes heating time and 4 minutes of cooling time. The thinner 4 ply material was subjected to 50 cycles of 2 minutes heating time and 2 minutes of cooling time. Due to the cycling process the absorbed moisture near the outer surface was quickly driven off while the interior of the specimens retained a significant fraction of its original moisture content (see fig. 15).

Thermally cycling composite materials, equilibrated at 80% R.H., from room temperature to 473°F produced no observable damage. During this period, moisture is rapidly driven from the outer regions of the composite while the center of the material still retains a large portion of its original moisture content. If any significant damage was to be produced due to thermal cycling, it would have been expected to occur within the first portion of this cycling process when the rate of moisture loss was at its greatest.

Figure 15. - Moisture concentration profile of a 4 ply specimen during thermal cycling.
